Effect of Phosphorus in the Heat Treatment of En353 Steel Gears

Abstract: This article deals with the effect of phosphorus in the heat treatment of EN353 steel gears. The study was initiated due to the frequent rejections of EN353 steel gears because of the bending fatigue failure occurring during its service life. For manufacturing a gear, processes like hot forging, annealing, phosphating, Molybdenum disulphide treatment, cold forging and finally carburizing treatment are undertaken. After the manufacturing process, there was an indication of white layer beneath the carburized layer in the microstructure. This was found to be due to the presence of phosphorus by the use of Energy Dispersive X-ray Spectroscopy that seemed to be detrimental to the fatigue properties. The SEM analysis was also made to confirm the presence of phosphide. The effect of phosphorus was studied and dephosphating was carried out for various time intervals before heat treatment in order to eliminate the white phosphide layer and the standard time for dephosphating was analysed. This in turn could result in the increased fatigue life of the gears as the presence of phosphide was removed.

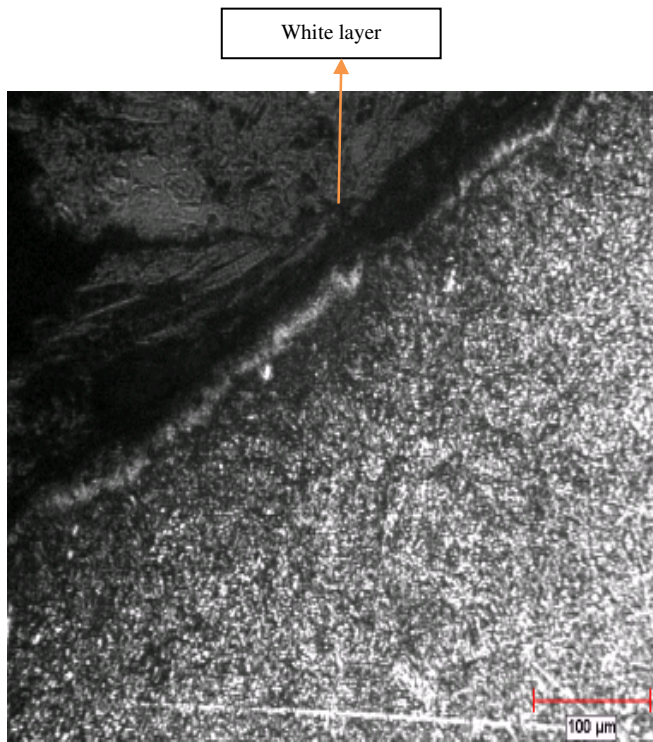
Fig. 1. Microstructure at 100x

It is clear from the microstructure that there is a white layer beneath the carburized layer.

The conventionally manufactured gear produced a white layer which was clear in the microstructural analysis as shown in figure 1. A SEM analysis was done on the white layer to fix the region for EDAX study. From the EDAX study, the compositional analysis indicated the presence of phosphorous which might have come from the phosphating process.

This white layer, being detrimental to the gear life was removed using dephosphating prior to heat treatment. Based on the observation it was confirmed that the white layer was removed in all the three trials. Considering the speed of production and time constraint dephosphating time of 5min is considered as the standard time.

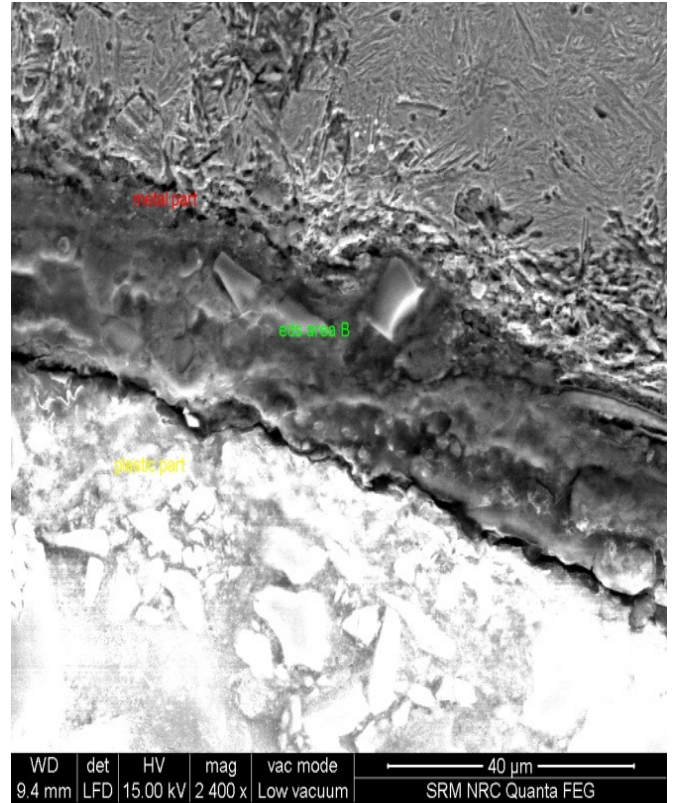
Fig. 2. SEM image

The SEM analysis was performed on the sample and the white layer was examined further by EDAX study.

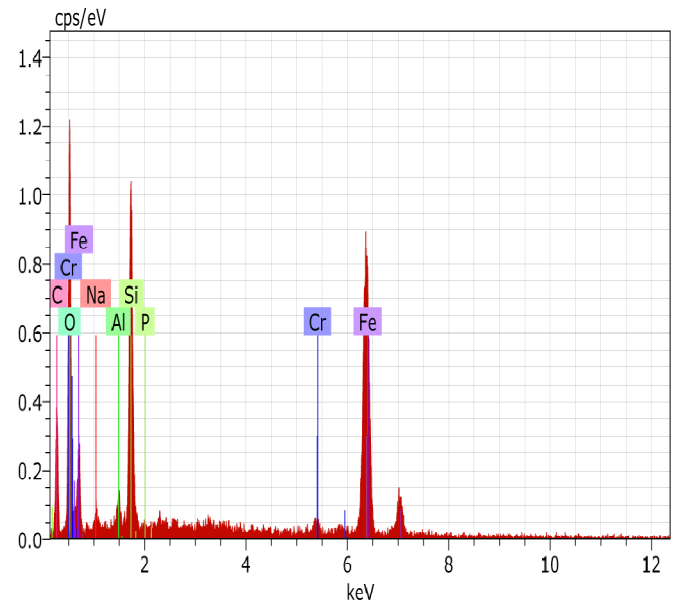
Fig. 3. EDAX image

The EDAX study was performed over the white layer area and the observations were made where the presence of phosphorous was highlighted.

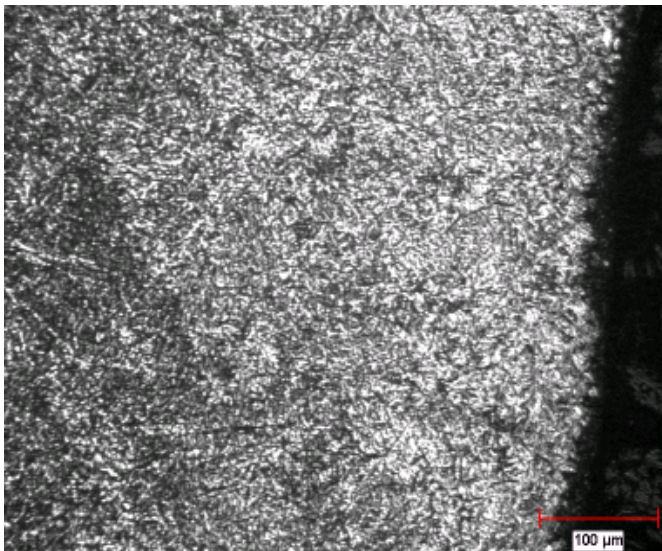
Fig. 4. Trial 1 microstructure

Prior to heat treatment dephosphating was done for five minutes and the following microstructure was observed.

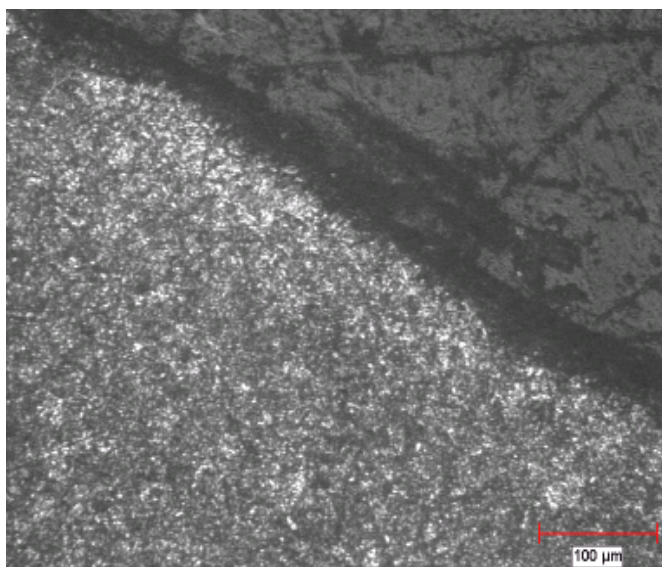
Fig. 5. Trial 2 microstructure

Before heat treatment dephosphating was done for ten minutes and the following microstructure was observed.

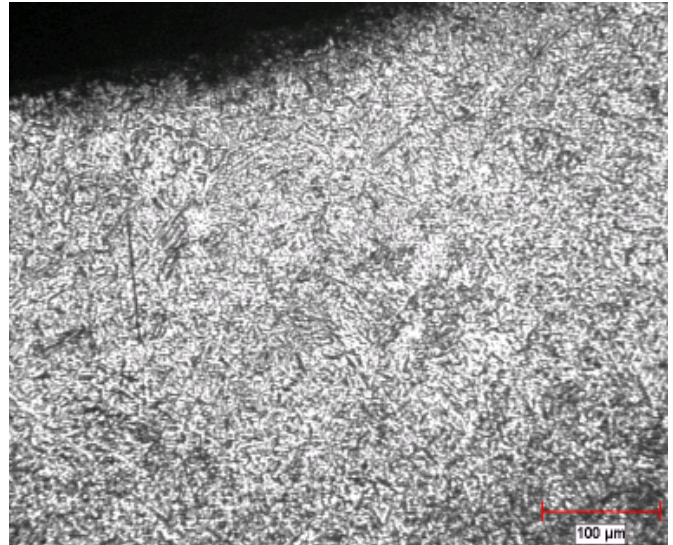
Fig. 6. Trial 3 microstructure

Prior to heat treatment dephosphating was done for fifteen minutes and the following microstructure was observed.

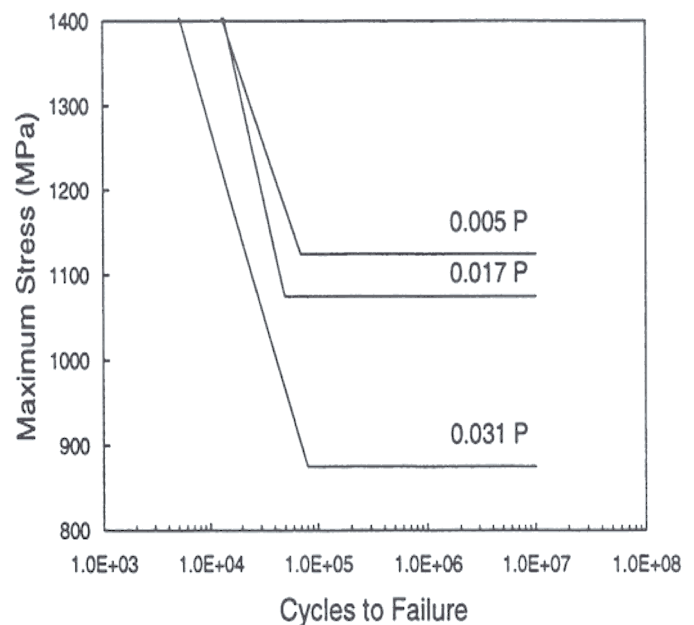
Fig.7. Effect of phosphorous content on the S-N curve of carburized steel^[1]

When bulk phosphorous content exceeded 0.017 weight percent, endurance limit dropped significantly. An increase in phosphorous from 0.017 to 0.031 weight percent reduced endurance limits from 1075 to 875 MPa.
