A case Study of Seismic Performance of Buildings Located at Wagnaghat and Kandhaghat, Solan, H.P

Nikita Gupta¹, Gagan Suman Sharma², Poonam Dhiman³

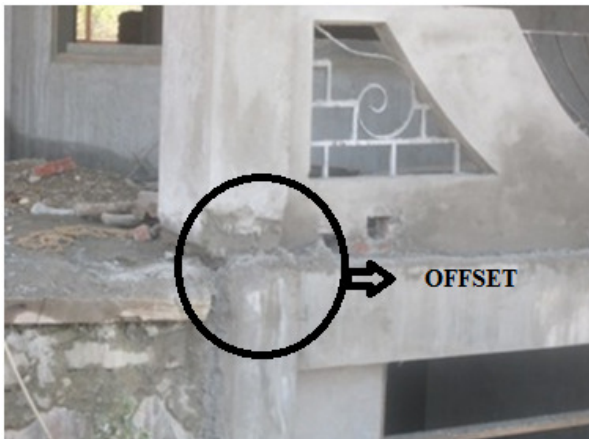
Fig. 1: Column Offset

The building shown in Fig. 1 is a hotel under construction located in Waknaghat. Column of upper storey has a horizontal offset with the lower column. It may be due to the poor workmanship. Due to the misalignment of the reinforcing bars and improper or no bonding of two columns, there is a possibility of sudden failure of this joint during an earthquake. At the construction stage, care must

be taken to avoid this irregularity correct alignment in the columns of the building and by employing good workmanship.

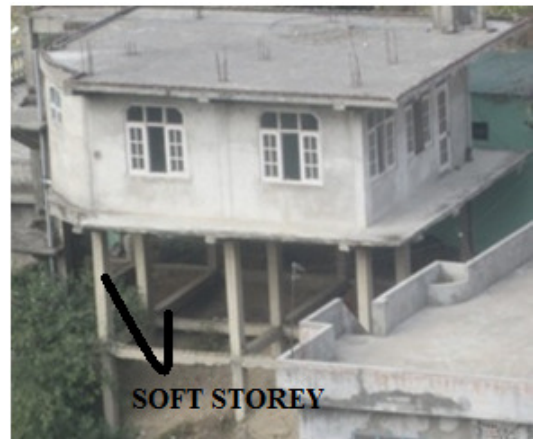
Fig. 2: Soft Storey

These stories are more likely to get collapsed or were severely damaged during earthquake. Many buildings with an open ground storey (soft storey) were observed (shown in Fig. 2, 3 and 4) in Kandaghat. Fig. 2 shows a residential house being constructed and the ground and first floor are left empty whereas a house is dwelled in second storey. Fig. 3 and Fig. 4 are also good examples of soft storey. This defect can be minimized by constructing shear walls at the ground level so as to eliminate the discontinuity in the lateral load resistance path and to increase stiffness of soft storey (making it comparable with other stories).

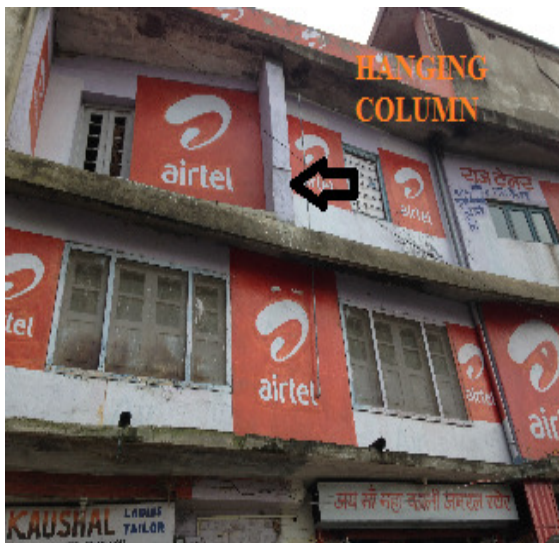
Fig. 5: Hanging columns or Floating columns

Buildings with columns that hang or float on beams at an intermediate storey and do not go all the way to the foundation, have discontinuities in the load transfer Path. It may lead to catastrophic failure of buildings. The buildings shown in Fig. 5 and Fig. 6 are located in the main market of Kandaghat. Fig. 5 is a residential building where people dwell in first and second storey and ground storey is used as shopping area. This building has hanging column whose load is going nowhere but borne by beams only. Fig. 5 clearly show that the column do not continue up to the foundation but rather end at an upper level. Due to this, Shear is induced to overturning forces to another resisting element of a lower level^[3] Thus, site Engineer must be aware of the fact that load transfer path should be continuous. All the columns and walls must extend to the foundation in order to mitigate horizontal ground motions. Fig. 6 also shows a residential building with a numbers of hanging, long and short columns (discussed in coming text). There must not be any floating columns in buildings.

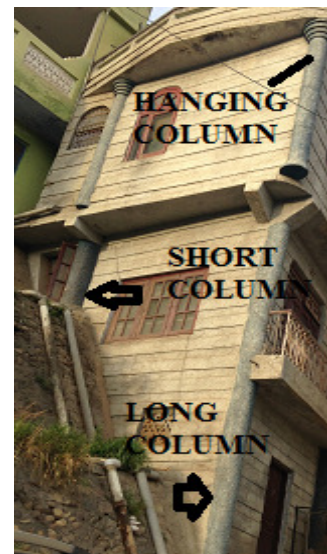
Fig. 6: Floating and short columns

Fig. 8 shows a building that is being constructed on a slopy land near Wagnaghat. It shows a long and a short column that is highlighted with double black lines. Fig. 6 also contains the same irregularity. Buildings on slopy ground have unequal height of the columns along the slope, which causes ill effects like twisting and damage in shorter columns ^[5]. Both the lengths of the column must be equal. This can be achieved by constructing masonry wall between the columns to eliminate the height difference between them.

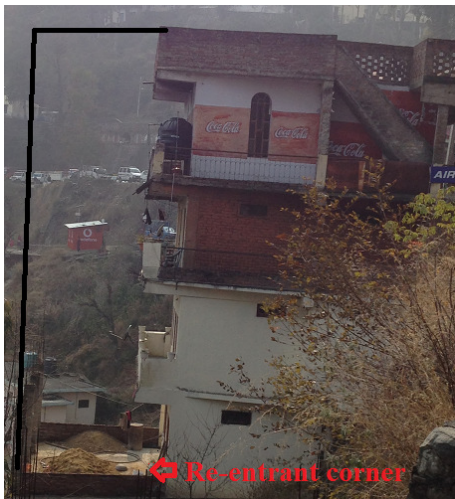
Fig. 7: Setbacks (Re-entrant corner)

According to IS 1893 (part 1): 2002, plan configurations of a structure and its lateral force resisting system contain re-entrant corners, where both projections of the structure beyond the re-entrant corner are greater than 15% of its plan dimension in the given direction ^[4] Buildings with vertical Setbacks cause two types of problems: (i) Sudden jump in earthquake forces at the level of discontinuity: The area in the building suddenly increases and the stress decreases. This creates a jump in the stress at the level of discontinuity (ii) Torsion. This defect can be eliminated by constructing the walls around the two free sides as shown by black line so as to produce a uniform regular plan building. Fig. 7 is a residential building located in Kandaghat which contains a re-entrant corner.

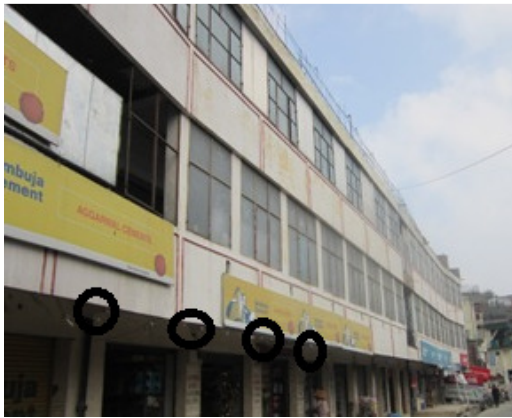
Fig. 9: Cantilever slab loaded heavily

earthquake. Fig. 9 shows a commercial building located in the market of Kandaghat. This long building has a cantilever slab that is loaded with heavy machinery. Fig. 10 shows a residential house situated in Kandaghat, in which the cantilever portion has been used as the living room. The extra weight loaded above proves to be detrimental during an earthquake. In order to correct this defect, in Fig. 9, columns must be provided at the cantilever ends as shown by black circles so that load is distributed uniformly. Whereas, in Fig. 10 the bottom portion of the cantilever must be either provided with one more column or must be covered with walls on the two sides.

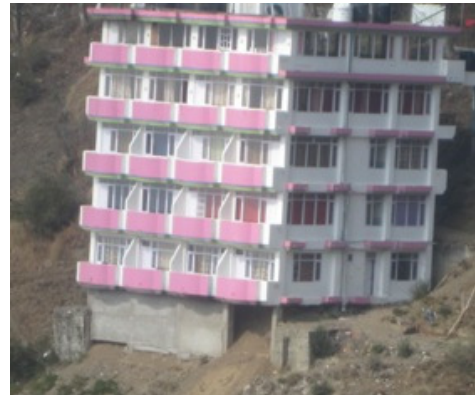
Fig. 12: Construction of Shear wall

4. Shear wall can be properly employed for increasing the stiffness where ever necessary and must be uniformly distributed. Fig. 12 shows a remedy for a soft storey. The ground storey which was earlier a soft storey is now being provided with shear walls.
