# Extension of Runway at Pantnagar Civil Airport for Water Logged Region

Pantnagar airport being a neighbor to the Rudrapur city is also a central hub for industries which demand an extension in length of the existing runway. Water logging is experienced at different locations, as this region receives a heavy amount of rainfall year long. This paper provides details of field inspection, laboratory test results and remedial measures suggested for lowering ground water table for future consideration of extension of the runway.

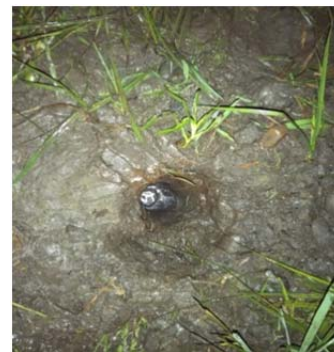
Fig. 1: Bore Hole at Point 2 (P2)

Co-ordinates: Latitude: 29.035521N  
 Longitude: 79.455629E  
 Elevation: 745 feet MSL  
 Bulk Density of Soil: 1.687g/cm<sup>3</sup>  
 Ground Water Table: 5 feet below soil surface

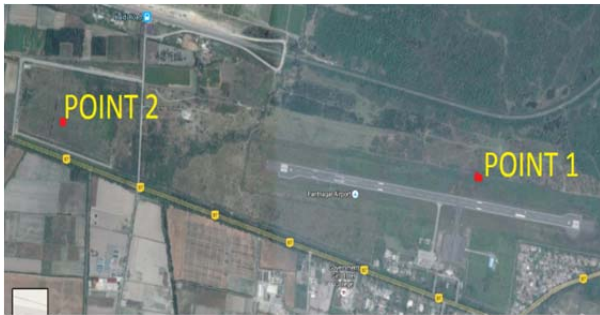
Fig. 2: Location of the Points of Boring i.e. Points P1 and P2

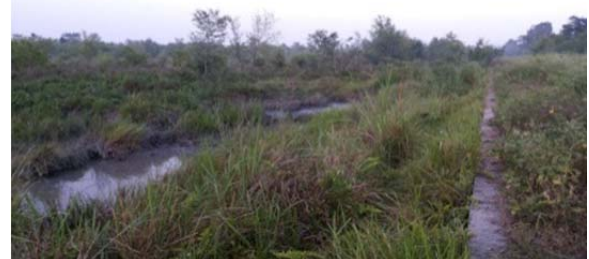
Fig. 3: Water Logging at Extension Site

There is also a problem of water logging being encountered in several locations. The major reason being the location of the airport in a heavy rainfall region which receives rainfall ranging from a normal 80 to 90mm precipitation to a maximum of 200 to 225mm, considering a single day duration. The second major reason is the poor drainage of soil, which can be justified from the fact that a high concentration of clay is present in the sub-soil at point P2. The clay content is 5.560% at a depth of 2.5feet and is as high as 19.120% at 7.5feet depth. It is also observed that the point P2 lies at a lower elevation than the present airport location hence, it is a prime location for water accumulation from the surrounding regions.
