A Study of Hot & Aqueous Corrosion of an Iron Phosphorous Alloy

Yashwant Mehta^{*a}, Mahak Fazal^a, Baiza Rafiqi^a, Tooba Shah^a and Vikas Chawla^b

^aNational Institute of Technology Srinagar

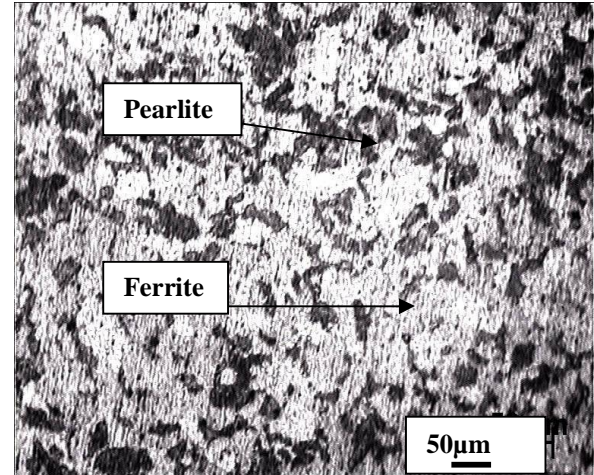
Optical microscopic analysis: The microstructures of both the steels contain ferrite (Figures 3.1 and 3.2).

Figure 3.1. ASTM-SA210 Grade A-1 boiler steel, 200X

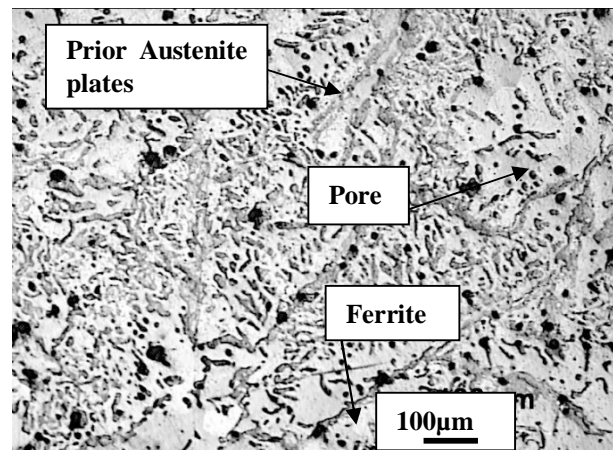
Figure 3.2. Rolled and forged alloy P-1, 100X

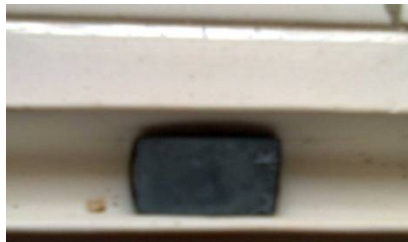
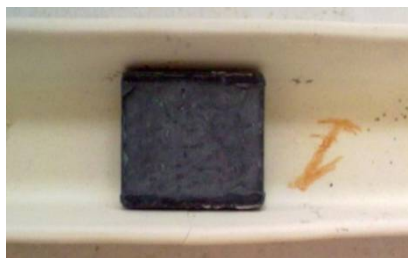
Visual Examination: The high temperature oxidation behaviour of uncoated A - 1 steel was visually examined for 30 cycles at 900°C . Uncoated A - 1 steel showed rapid deterioration till the completion of 5 cycles. Scale started to form on the surface due to rapid oxidation on the surface. After the 5th cycle of heating, scaling rate of the surface deteriorated till the 10th cycle was completed. Scale from the surface started peeling off in the form of thin layers. The layers showed a dull steel grey colour throughout the 30 cycles. The sample started to disintegrate by gradual peeling off of thin layers from the surface which started first at the larger surface of the sample while it gradually proceeded to the smaller areas. Deterioration of material continued at a decreasing rate till 30th cycle of heating. The cycle wise macrographs of oxidation of A-1 are shown in figure 3.3.

Figure3.3. The cycle wise macrographs of oxidation of A-1 in air

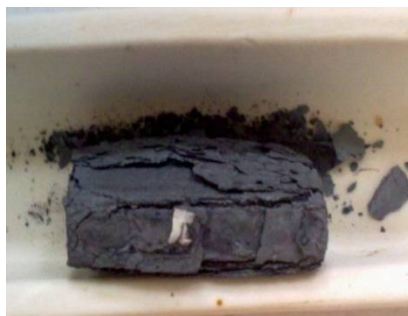
In case of P-1 steel, deterioration of the surface started rapidly due to the formation of oxide scale at the surface. The deterioration was not uniform unlike in A-1 sample. Cracks

appeared all over the surface during cooling after 5th cycle. Layers peeled off from the surface from 10th cycle onwards, in the form of small pieces and this peeling off continued for the rest of the cycles. Inner layers were grey in colour and dull in appearance. This deterioration slowed down in subsequent cycles. The cycle wise macrographs of oxidation of P-1 are shown in figure3.4.

Figure3.4. The cycle wise macrographs of oxidation of P-1 in air

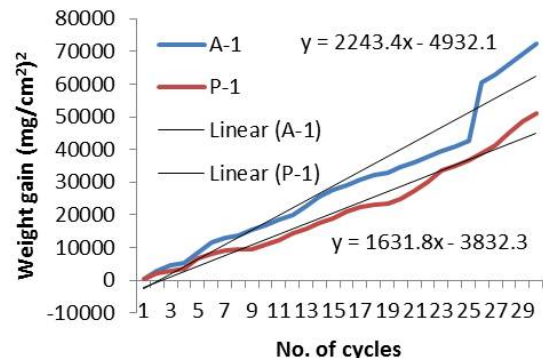
Thermo gravimetric study: The thermo gravimetric analysis was done for grade A-1 and P-1 steels for high temperature oxidation. The change in weight after each cycle was calculated and was plotted against number of cycles as shown in figure3.5. The rate constants for the high temperature oxidation of Grade A-1 and P-1 steels were calculated from figure 3.5 as $6.23 \times 10^{-13} \text{ gm}^2/\text{cm}^4\text{s}^{-1}$ for Grade A-1 and $4.53 \times 10^{-13} \text{ gm}^2/\text{cm}^4\text{s}^{-1}$ for P-1 steel. This is indicative of better resistance to high temperature corrosion, of P-1 steel, as compared to Grade A-1.

Figure3.5. (Weight gain/area)² plot for Grade A-1 and P-1 steel after high temperature oxidation at 900 °C for 30 cycles

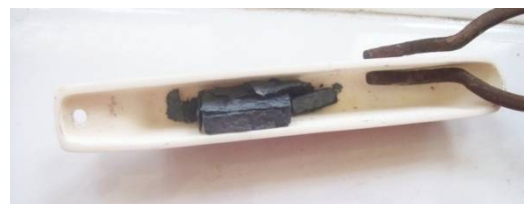
Visual Examination: A-1 was visually examined for 10 cycles at 900 °C in aggressive environment of molten salt Na_2SO_4 - 60% V_2O_5 . The A-1 steel sample showed small cracks in 1st cycle. The cracks increased in size onwards along with the spalling of scale. It was observed that A-1 steel severely deteriorated with considerable sized scale pieces, which peeled off. Dull grey coloured layers were formed on the steel surface. The 5th cycle macrograph of corrosion of A-1 in molten salt environment is shown in figure3.6.

Figure3.6. The 5th cycle macrograph of oxidation of A-1 in molten salt environment

It may be observed that the base material was not able to withstand the salt at 900°C after the 1st cycle itself as it underwent rapid spalling. However, the P-1 steel scale did crack after the 1st cycle, but the deterioration was to a lesser extent than A-1. After which the scale started chipping off. This may be due to the difference in coefficient of thermal expansion of the substrate and the coating applied, which resulted initially the separation of the coating from the substrate exposing the substrate to the molten salt.

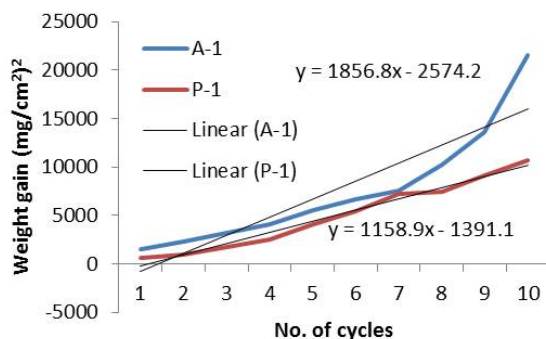
Figure 3.8. (Weight gain/area)² plot for Grade A-1 and P-1 steel in molten salt environment for 10 cycles

The rate constants for Grade A-1 and P-1 steels were calculated from figure 3.8. It was found to be $5.155 \times 10^{-13} \text{ gm}^2/\text{cm}^4 \text{ s}^{-1}$ for Grade A-1 steel and $3.216 \times 10^{-13} \text{ gm}^2/\text{cm}^4 \text{ s}^{-1}$, which indicates better corrosion resistance of P-1 steel.

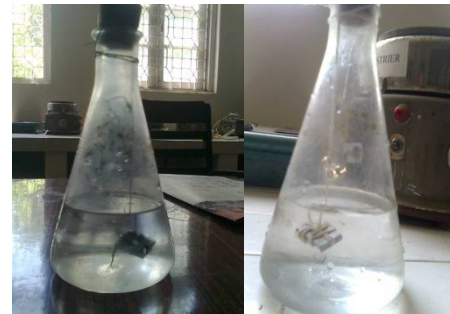
Visual examination: The sample of grade A-1 was visually examined after keeping in a salt solution for 30 days (Figure 3.9). It was found that the corrosion took place with the formation of a thin, porous, rusty brown film consisting of oxides. This unstable oxide film formation leads to a decrease in weight of the sample.

The sample of P-1 steel was visually examined after immersion in aqueous salt solution for 30 days (Figure 3.9). A rust coloured, thin porous and unstable layer of oxide formed on the surface on dissolution.

Figure 3.9. A-1 and P-1 suspended in salt solution

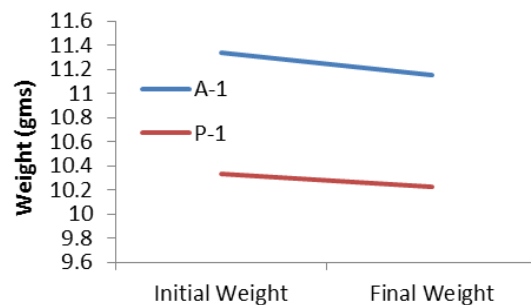
Thermo gravimetric analysis: The corrosion kinetics for A-1 and P-1 steels in aqueous environment at room temperature have been studied. The weight loss data have been plotted as shown in figure 3.10 below.

Figure 3.10 Plot of weight loss observed after aqueous corrosion

- (5) The behaviour of A-1 and P-1 samples in aqueous media (3.5 wt% NaCl) is almost same as both show almost equal amount of weight loss after a time period of 30 days.
