# Land and Water Conservation–Abandoned Quarries in Bangalore

*This paper discusses the environmental impacts of stone quarrying in Bangalore and recommends effective means for dealing with the practical aspects of conservation and reclamation within the context of environmentally responsible business practices.*

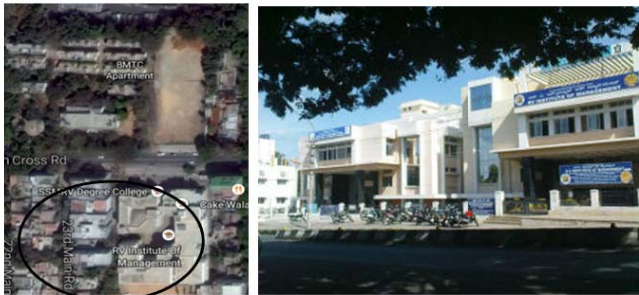
This site is located in the heart of the city in a completely developed urban setting. Quarrying activity had been discontinued more than a decade and a half ago. The land use of this site was changed to form institutional land about 7 years ago and a college was constructed. No traces of the quarry can be seen now. The depression in the quarry site has been utilized to form basement and the site has not been filled unnecessarily to match the level with the surrounding.

**Fig. 1: Location map of Jayanagar T block quarry site showing the current status**

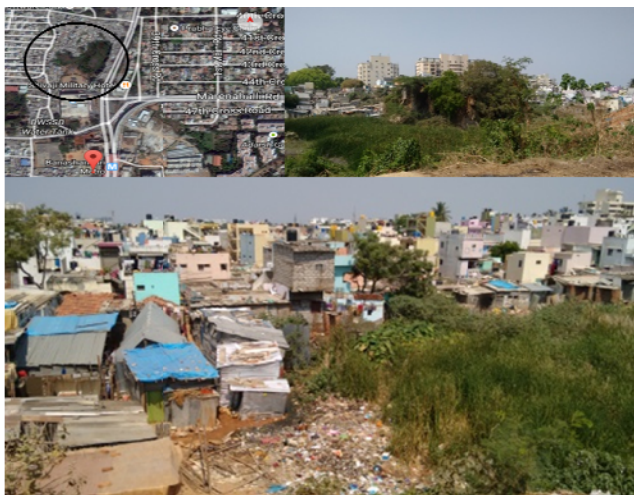
Quarrying activity had been discontinued more than a decade ago. One of the quarries is abutting the bus stand and the other quarry is abutting the new metro station. Though this part of the city has been dense urban growth over the past 10 years, these two quarry sites have been neglected completely. The quarry site next to the bus stand is completely degraded with water pooling in low lying areas with anaerobic weedy growth and squatter settlement in relatively higher areas in unhealthy living conditions. It's a sore to the eye.

**Fig. 2: Location map of Banashankari quarry site next to bus stand showing the current delapidated status with squatters**

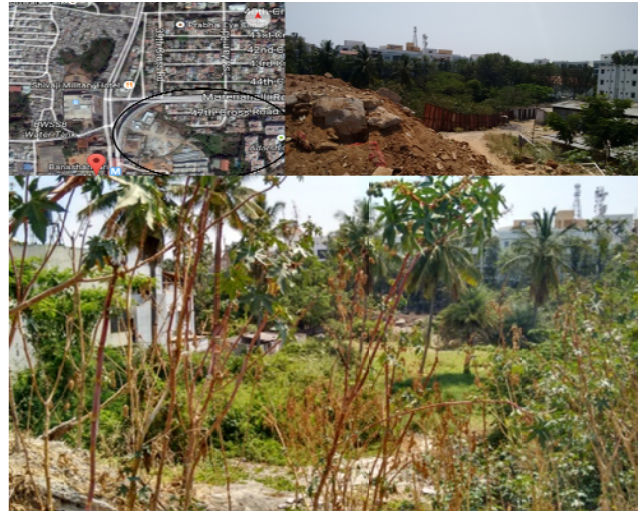
The quarry next to the new metro station also has water pooling at the low lying areas with squatter settlements created by the metro workers. There is a government proposal of converting this land into a park after completion of the ongoing metro work.

**Fig. 3: Location map of Banashankari quarry site next to metro showing the current delapidated status**

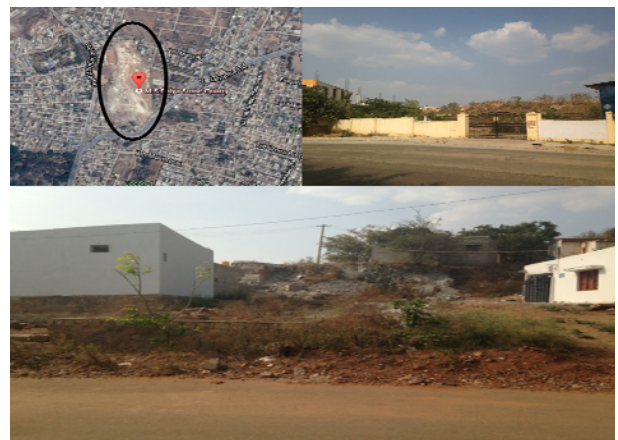
This quarry site is in the new extensions of Bangalore. Quarrying activity was stopped about 7 years ago. There has been a sudden development and growth of the surrounding area over 5 years with many residential developments mushrooming around the quarry site. Despite this, the quarry site has been neglected. There is water pooling in the quarry site which overflows into the adjacent road network carrying the sludge during monsoon. A thesis has been prepared by a Bangalore based architecture student after thorough study on how this quarry site can be rehabilitated and converted into museum cum recreation centre.

**Fig. 4: Location map of M.S. Palya quarry site showing the urban sprawl and the current status**

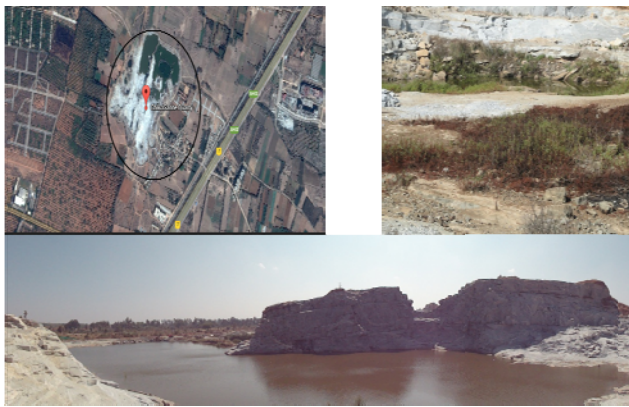
This quarry site is in the outskirts of Bangalore close to the Bangalore International Airport. The zones around the airport have been identified as sensitive zones, hence the quarrying activity has been stopped over the past few months. The surrounding area is sparse residential development with predominant agricultural activity. Water pooling is noted in the low lying area. The same can be further developed into a water body with the construction of check dams at appropriate location to help store water which can be used for irrigation purpose for the agricultural lands in the vicinity. The overflow rainwater can be channelized to the nearby lake. In some parts of the quarry land growth of pioneer species can be observed. Favorable conditions can be provided for the plant succession to facilitate growth of climax community.

**Fig. 5: Location map of Chikkasanne quarry showing the current status of the site with water pooling and growth of pioneer species**
