# Road Safety Audit to Assess Safety Performance of Tonk Road, Jaipur

**Abstract**—Road safety audit is the procedure for evaluating probable accidents and safety performance in the planning of roads, advancement of existing roads. The roads selected for the audit is Tonk road (17.2 km), Jaipur. The number of road accidents recorded on tonk road was 252 in 2012 total accidents in Jaipur in 2012 was 2848. The data compiled by the national crime records bureau (NCRB) claims that the number accounts 8.85% of the total cases of road accidents registered in the Tonk road, Jaipur.

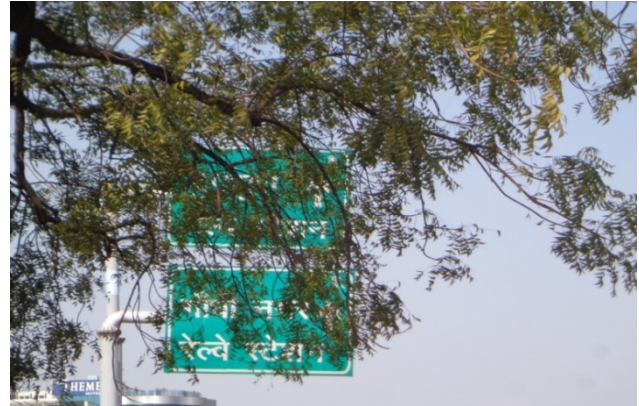
Location: Gandhi nagar railway station

An Informatory sign obscured by overgrown vegetation

- Informatory sign are obscured by the overgrown vegetation , shoulder aren't paved , police booth is damaged at the kumbha marg, and median is damaged. So our team recommends the JDA for the implement.
- Parking area aren't available at many location but there parking is available where is more encroachment like as hawkers, vendors etc. so we recommend to the traffic police department for the control of the this.
- Buses aren't stopped at the bus stop because the bus stop is encroachment the mini buses and auto rickshaw. So stop at we recommend the police department for the control.
- Amenities for pedestrian for path way aren't provided so we recommended the JDA for providing path way (Hawkers exclusive zone, cover from sun and rain etc.)

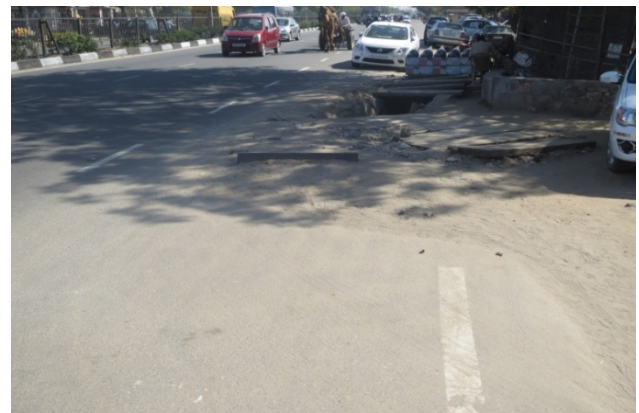
Location: Gaushala road

The shoulders are not paved but may be used for broken down vehicles. The transition between the surfaced traffic lane and the shoulder, however, is hazardous.

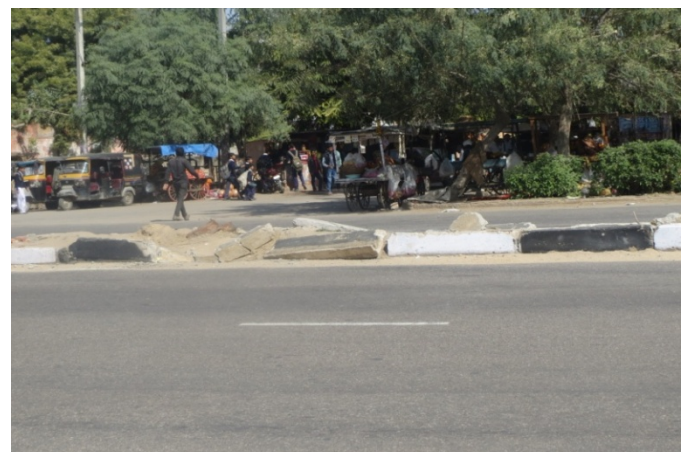
Location: sector-8, pratap nagar

Median had been damaged during a crash and not repaired by longtime
