# Free the Footpaths: Urban Design Concepts to Improve Pathways; Case of Punjagutta

Divya Vora<sup>1</sup> and Ar. Shivangi Narayan<sup>2</sup>

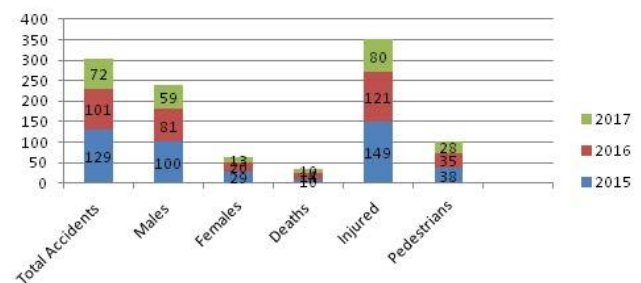
**Graph 1: Accidental Data of Panjagutta Junction**

Over the past 3 years the total injured people at the junction are 350 and out of this the pedestrian accidents alone are recorded as 33 on an average.

Accidental data of Panjagutta Jn., records 350 accidental injuries in 3 years. Pedestrian accidents alone accounts for 33% on an average. 42% of pedestrian accidents have occurred between 6-12pm. High accident rate in the evening is due to lack of visibility and motorist behavior.

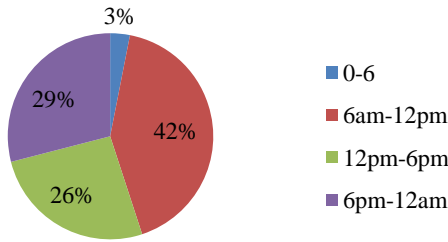
Source: Primary Survey, 2018, Author  
**Graph 2: Pedestrian Accident Data of Panjagutta Junction**

42% of pedestrian accidents occurred between 6-12 pm. High accident rate is seen in the evening is due to lack of visibility and motorist behavior. Absence of pedestrian pathways are another cause for high accident rates.

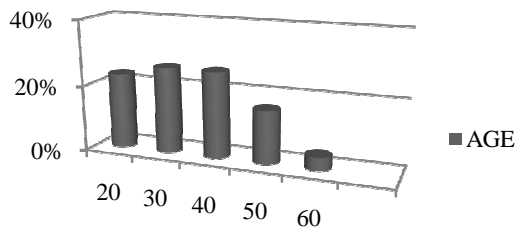
Source: Primary Survey, 2018, Author  
**Graph 4: Pedestrian Age-Wise Analysis of Panjagutta Junction**

Age groups from 10-40 contribute 75% of total pedestrians on road. Most of the pedestrians are either student or employee. People above age 50 don't feel safe on walking on roads.

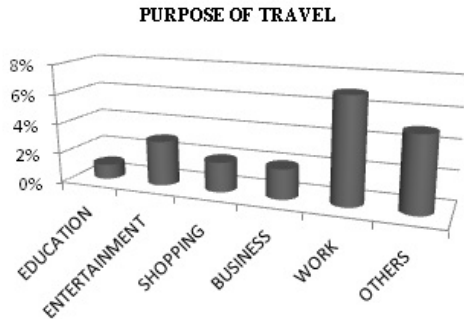
**Graph 9: Purpose of Travel Analysis of Panjagutta Junction**

The major junctions Panjagutta, has mixed pedestrian activity with students and working class (employees).

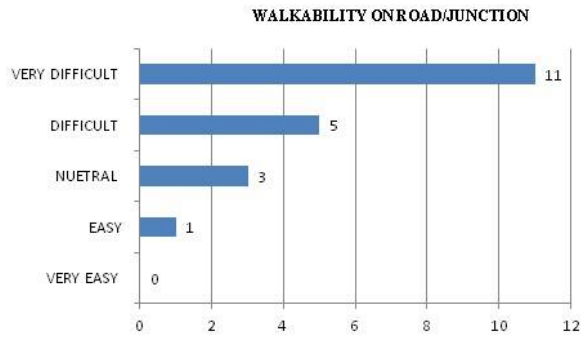
**Graph 10: Walk ability Analysis of Panjagutta \**

Walkability at all the Roads/junctions are not easy for pedestrians and 40% of the pedestrains feel that it is very difficult to cross the road.

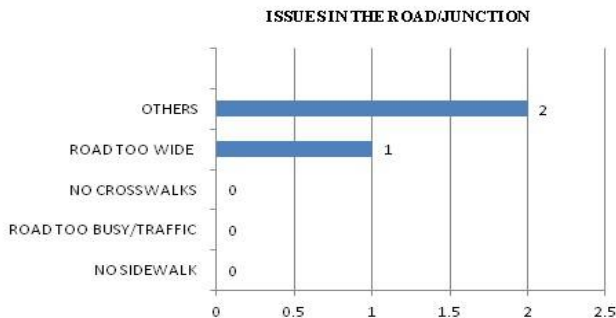
**Graph 11: Issues at Panjagutta Junction**

The major issues pedestrians find on roads are the existing roads are filled with traffic.

There are no crosswalks for pedestrians to cross safely.

Punjagutta roads are difficult to cross due to dense traffic.

The junction does not have a clear path way for pedestrians thus, pedestrians try to cross the road wherever they get the chance.

Zebra crossing at the junctions are not visible and must be repainted.

There is no pedestrian crossing time limit provided at the junction, this makes the pedestrian movement more uncomfortable.

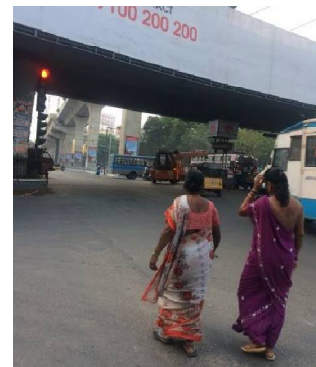
**Picture 1: Absence of zebra crossing**

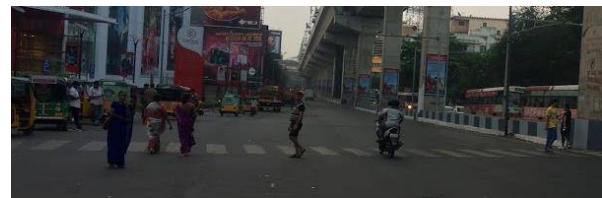
**Picture 2: Uncontrolled pedestrian movement at the junction**
