# Open Ground Storey Buildings under Seismic Loading in Chandigarh - A Case Study

**Abstract**—According to the physiographical and tectonical study, india can be divided into three broad categories: peninsular india, indo-gangetic plains and the extra-peninsular india (himalayas). The extra-peninsular india or the himalayas have recently observed faulting in the himalayan foothills and chandigarh being situated at the seismic zone iv have to soon be planned to design the economical and seismic safe buildings.

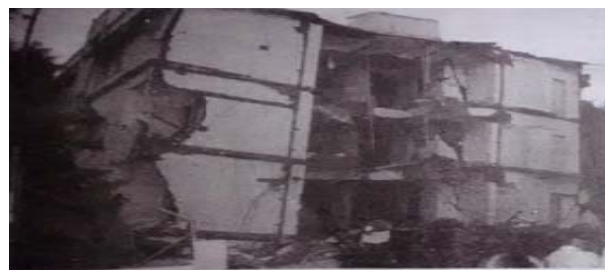
The perimeter columns of the ground storey are discontinued in the upper stories and floating columns are provided along the overhanging perimeter of the building. (see Fig. 1)

Fig. 4: Failure of reinforced concrete columns with floating columns

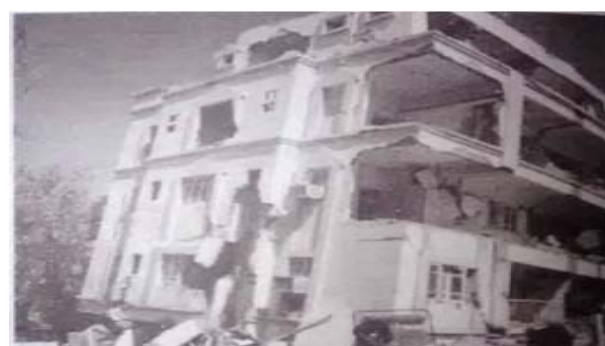
Fig. 5: Failure of the reinforced concrete building

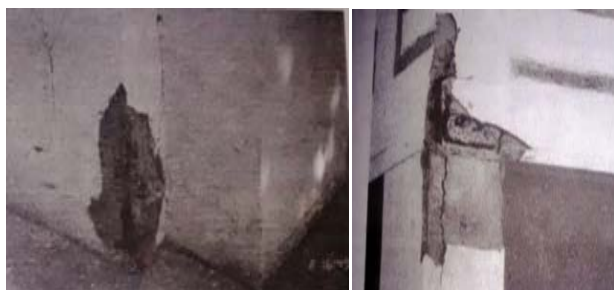
The faulty construction practices and lack of quality control contribute to the damage of buildings. It was observed that the ratio of sand was high. The recycled steel was used as reinforcement. The corrosion of reinforcement bars occurred due to: (a) insufficient concrete cover, (b) poor concrete placement, and (c) porous concrete.

Fig. 7: Damage due to corrosion of steel at column force and at beam column joint
