Commercial Buildings and their Relationship with the Economic Situation during a Period of Transition towards Capitalism: Site Study of Historical Commercial area in Thapae, Chiang Mai, THAILAND

Chompoorath Chompoonoot

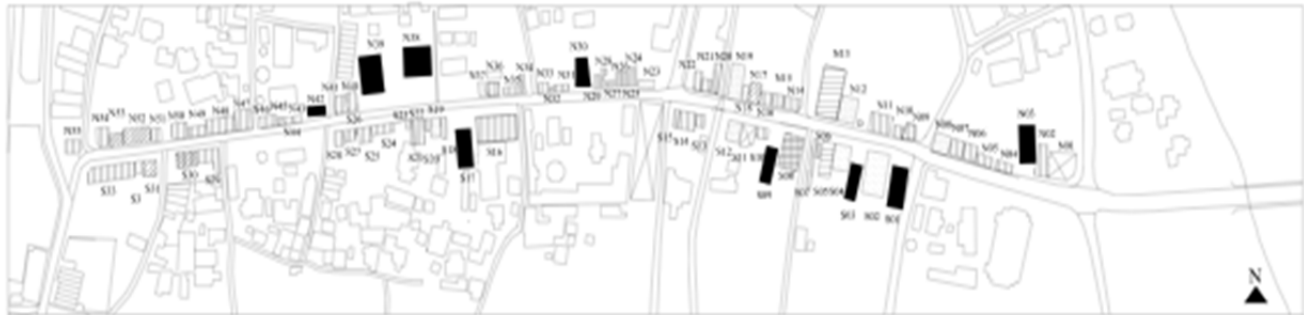
Table 1: Categorization of buildings in Thapae Road and period of formation.

1870	1900	1920	1930	1940	1950	1960	1970	1980	1990	2000	2010	2015
				1914 storage				1980-2000 rented for shop			Abandoned	N08
				1930 Dwelling + Shop 1st FL								N12
												N18
												N19
												S02
												S04
												S12
												S20
												N04
												N05
												N06
												N07
												N09
												N10
												N11
												N14
												N15
												N16
												N27
												N28
												N35
												S21
												S08
												N13
												N38
												N39
												N17
												S30

As shown in Table 1, buildings were categorized into six types using current building characteristics. A representative sample of 27 was taken from 88 buildings to access the historical data: shops before the modern period, 8 from 15 (53.3%); shophouses from the modern period, 14 from 54 (25.9%); convenience stores, one building in the study area, two banks from 9 (22%), two hotels from 4 (50%) and etc. are not concentrate.

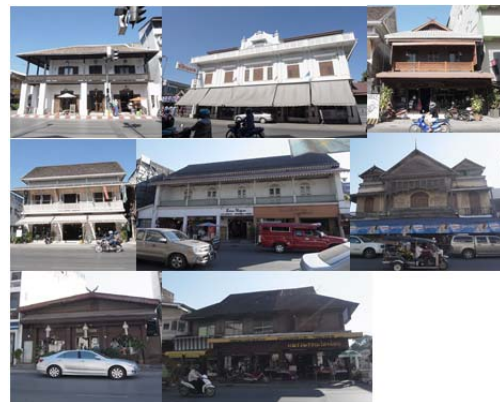
Fig. 2: Characteristics of shops prior to modern style: N08, N12, N18, N19, S02, S04, S12, S20 (photo taken by the author).

4.1 Shop prior to modern period. These buildings were created during 1900–1930. Three were originally shops, four were created for residential functions, and one for the storage of products for sale at Waroros market. The oldest building is N18, and presumably created before 1899. The building is a double-floor wooden house, characteristically similar to the decorative buildings in Myanmar, Western and Sino-Portuguese. The door, door frame, and window frame are wooden.

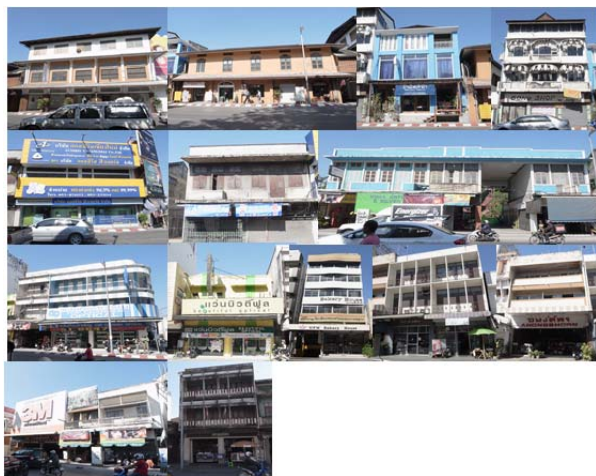
Fig. 3: Characteristics of shophouses in after modern period: N04, N05, N06, N07, N09, N10, N11, N14, N15, N16, N27, N28, N35, S21 (photo taken by the author).

4.2 Shophouse in modern period. These buildings were constructed during the period 1930–1980. The historical photograph shows that wooden shophouses existed on Thapae Road before the modern style era. The oldest building is N05, created in 1921 and the first of concrete construction in Chiang Mai, in the period before modern Thai style, where the space was divided into five units for rent and business activities. In addition, N04 was created ten years later by the same owner for living accommodation. The majority of buildings are modern Thai style, and the main characteristics are vertical and horizontal eaves, with spaces divided into units for rent.

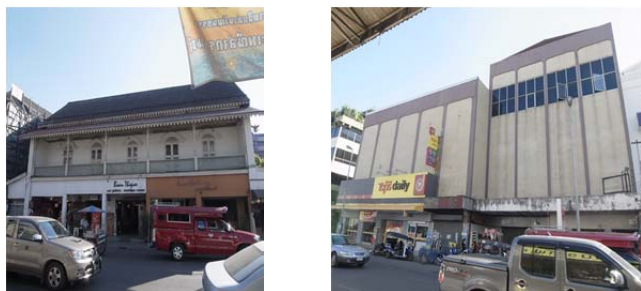
Fig. 4: Characteristics of convenience store: S08, N13 (phototaken by the author).

4.3 convenient store. The first modern convenience store in Chiang Mai was created in 1957 and called “Tantrapan Thapae” (S08). Before the creation of this building, there was no public open space for trade or entertainment. The first public building for trade was created in 1927 (S04) because other buildings are joint spaces for living and trading.

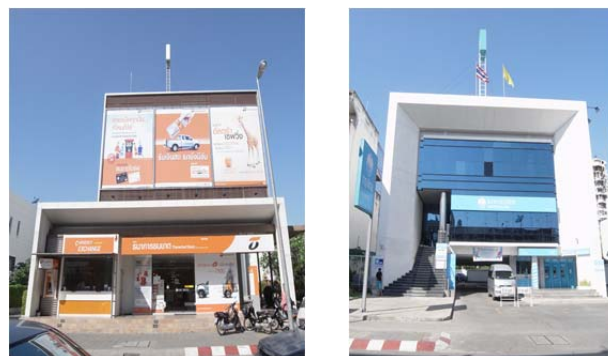
Fig. 5: Characteristic of banks: N38, N39 (photo taken by the author).

4.4 Bank. In Thapae Road, banks were constructed in 1963. Before the creation of banks, this area contained wooden houses. The owner of N38 sold it to a Thai politician (Mom

Rajawongse Kukrit Pramoj) for construction of the BBC Bank which was then sold to the Tanachat Bank, where it still stands. N39 was sold in 1963 to Krung Thai Bank.

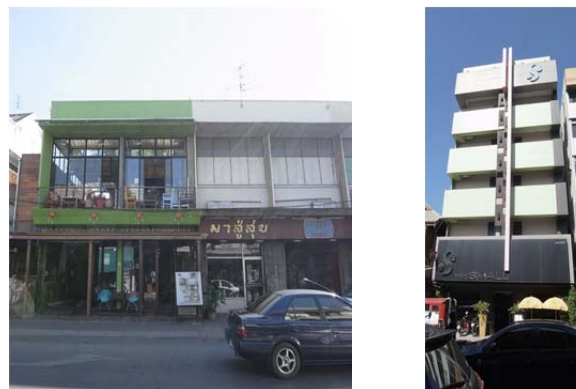
Fig. 6: Characteristic of hotels: S30, N17 (photo taken by the author).

4.5 Hotel. The representative samples in the study area were renovated from commercial spaces and shophouses. For example, N17 was originally created between 1980–1990 as a shop, S30 was renovated and two units of shophouses were converted into a hotel in 2013. The characteristics of S30, a shophouse in the modern Thai style, show separate units for rent and business. Two units of the building were renovated to provide a hotel lobby and reception.
